Manhole Inspection Summary

Manhole # **S29C__002MH**

Insp Date: **5/27/09 4:11 PM**

Location Address: **MARTIN LUTHER KING BLVD** Cross Street: **W FRANKLIN ST**

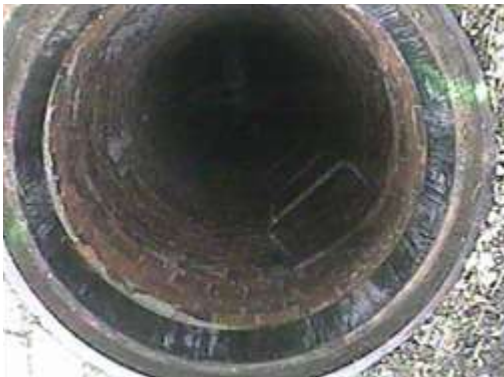
Defect 1

Steps Count: **10** Missing: **0** ☒ **Corroded**

CORRODED STEPS

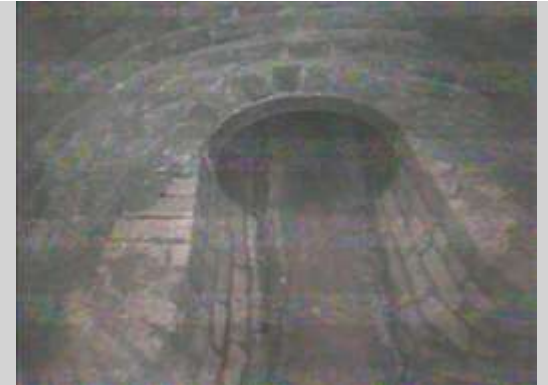
12 O'Clock Outflow

18 in. Circular Gravity Sewer
Pipe Out @ 12 O'Clock

Pipe Height: **13.2** (in.) Rod and Bar
Pipe Material: **Clay** ☐ Pipe Lined
Invert Depth: **22.26** (ft.) Flow Characteristics: **Fast**
Deposits: ☒ None ☐ Mud ☐ Sludge ☐ Debris ☐ Grease
Silt Depth: (in.) Deposits Extent:
Infiltration: **None** Pipe Seal Cond: **Sound**

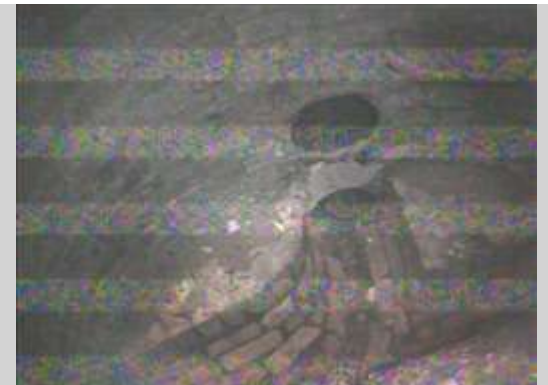
3 O'Clock Inflow

10 in. Circular Gravity Sewer
Pipe In @ 3 O'Clock

Pipe Height: **6** (in.) Rod and Bar
Pipe Material: **Clay** ☐ Pipe Lined
Invert Depth: **20.84** (ft.) Flow Characteristics: **None**
Deposits: ☒ None ☐ Mud ☐ Sludge ☐ Debris ☐ Grease
Silt Depth: (in.) Deposits Extent:
Infiltration: **None** Pipe Seal Cond: **Sound**

Drop: **Outside Direct**
Angled: Reading: (ft.)
Inv Depth: **21.28** (ft.)

Drop Condition: **Open**

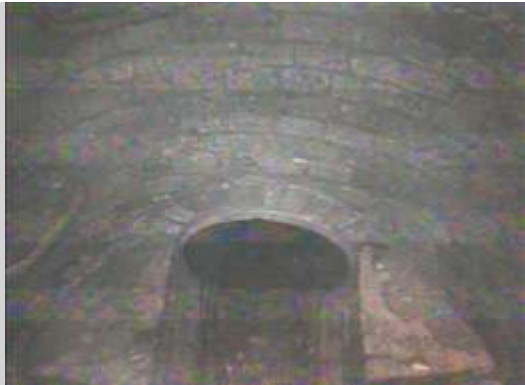
6 O'Clock Inflow

Pipe Height: **15.6** (in.) Rod and Bar

Infiltration: **None** Pipe Seal Cond: **Sound**

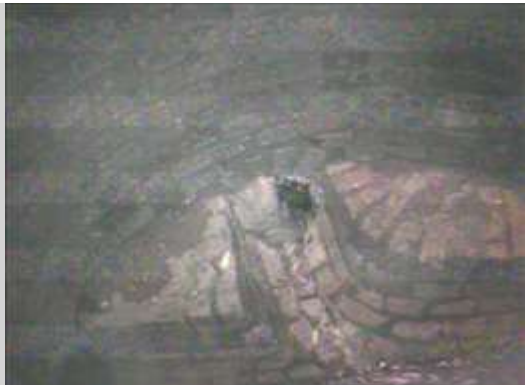
9 O'Clock Inflow

Infiltration: **Weeper** Pipe Seal Cond: **Sound**

Connects To: **Stub connection / abandoned**
